Connecticut Coastal Structures Inventory Study

SECTION 22
CONNECTICUT COASTAL STRUCTURES INVENTORY STUDY

PHASE I - NEW LONDON COUNTY

APPENDIX D
ATLANTIC QUADRANGLE
RECORDS OF STRUCTURES WITH PHOTOGRAPHS

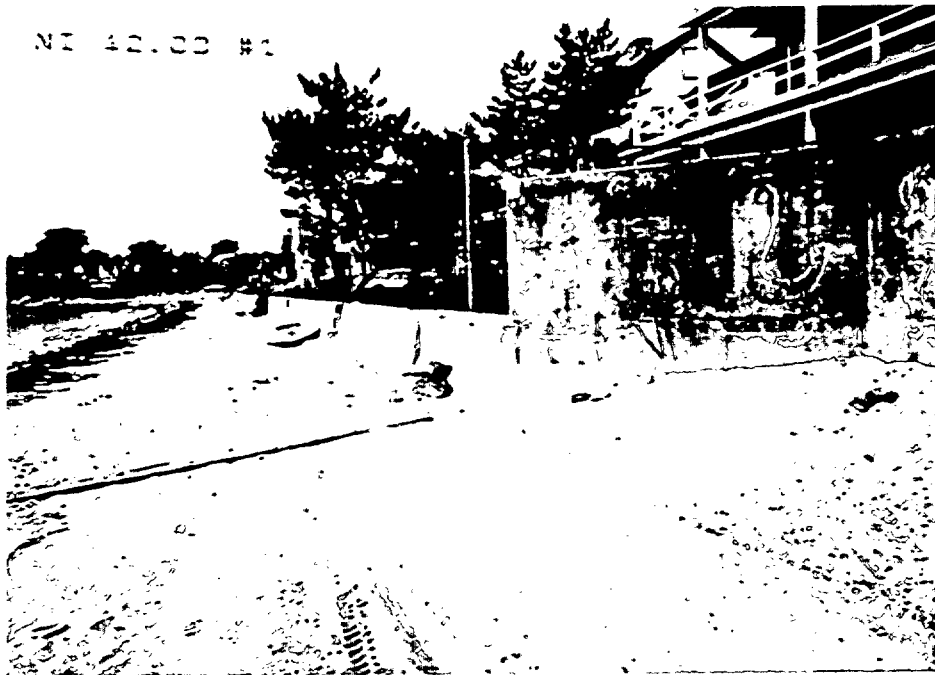
TYPE OF STRUCTURE: SEAWALL CONDITION: FAIR
MAIN FUNCTION : PROTECTS PARKING LOT AT CRESCENT BEACH AND 8 BACK
MATERIAL : CONCRETE

APROX L=650 FT (SEE QUAD), W= 1 FT, H= 4 FT ABOVE MHW
WALL HAS SEVERAL CRACKS

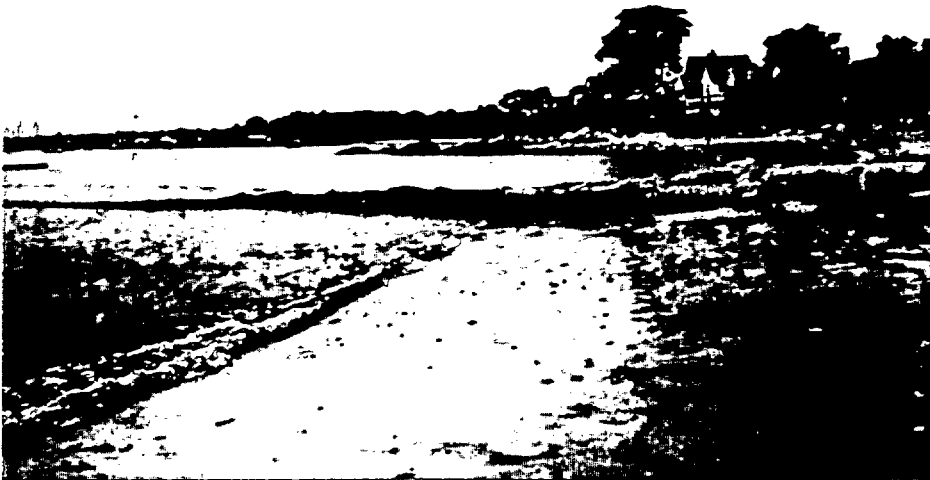
NI 43.00 #1

SHORE: SANDY BEACH. BUILT 1982.

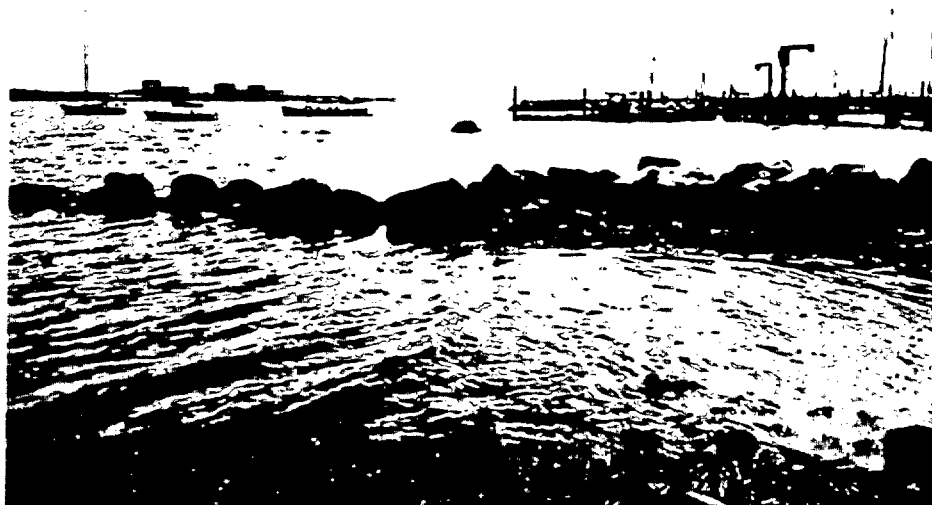
NI 44.00 #1

TYPE OF STRUCTURE: GROIN CONDITION: POOR
MAIN FUNCTION : PROTECTS OPENING OF DRAINAGE PIPE GOING UNDER SHOR
MATERIAL : STONE

SHORE: ROCKY BEACH

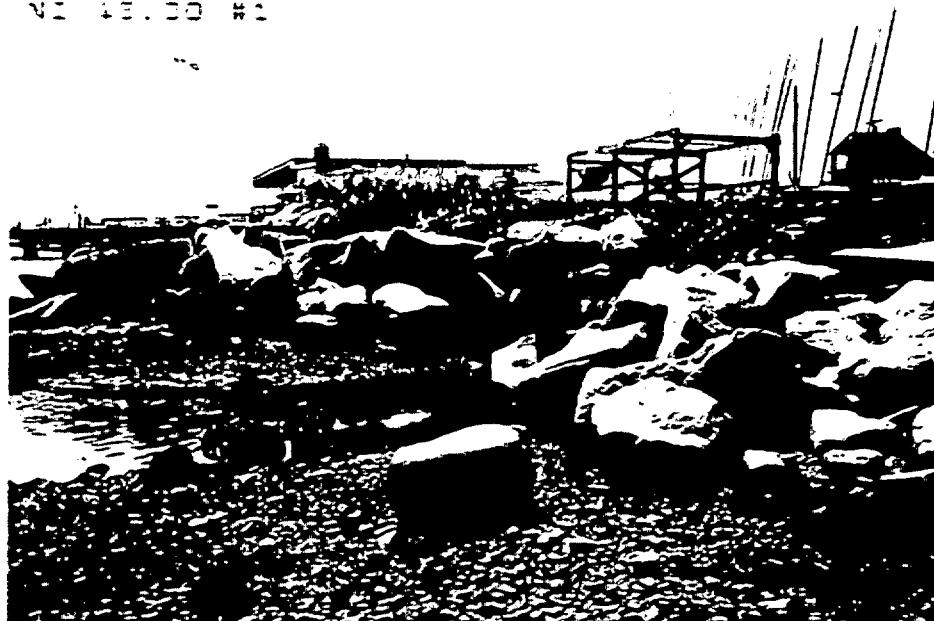
VI 48.00 #1

TYPE OF STRUCTURE: REVETMENT CONDITION: GOOD
MAIN FUNCTION : SUPPORTS SLOPE AND CONTROLS EROSION AROUND DRAINAG
MATERIAL : STONE

SHORE: ROCKY BEACH

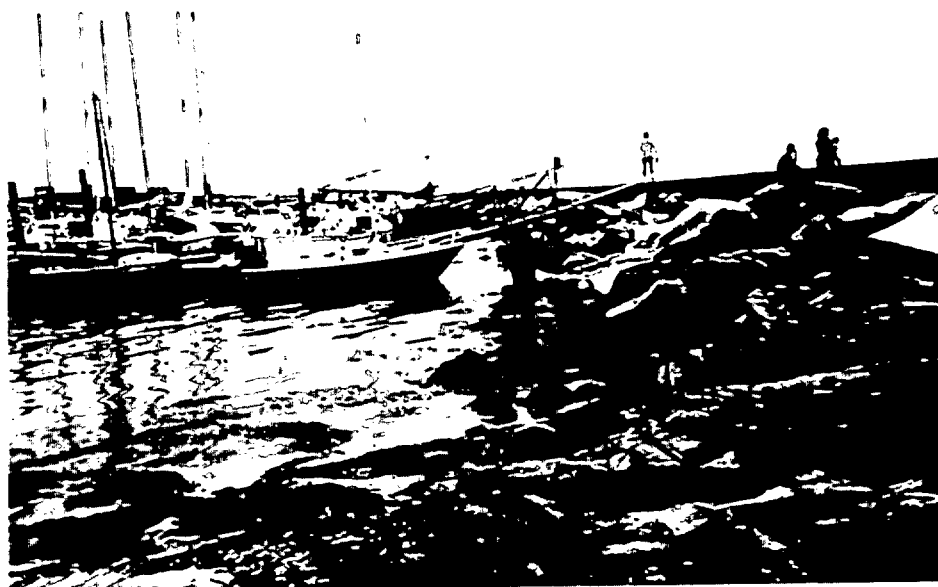
NI 47.00 #1

TYPE OF STRUCTURE: BREAKWATER CONDITION: GOOD
MAIN FUNCTION : PROTECTS YACHT CLUB SLIPS, MOORING AREA, DOCKS FRO
MATERIAL : BOULDERS

BREAKWATER CAPPED BY CONCRETE DECK
APROX L= 213 FT, W= 12 FT DECK ONLY, DECK AND FOUNDATION 20
FT, H= 6 FT ABOVE MHW

SHORE: EXPOSED BEDROCK TO NORTH
SANDY BEACH TO SOUTHWEST

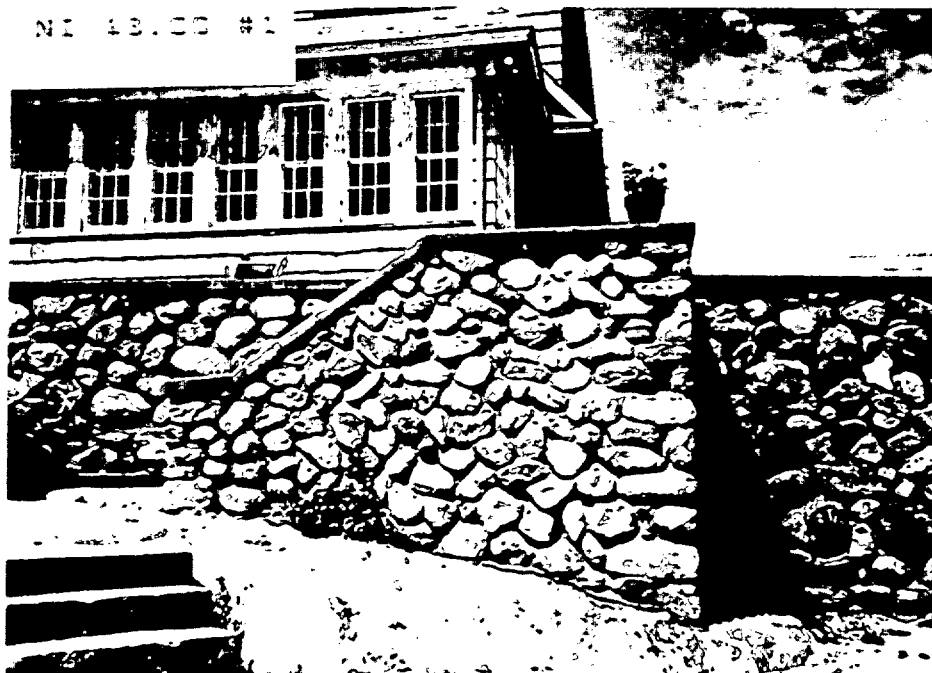
TYPE OF STRUCTURE: SEAWALL CONDITION: GOOD
MAIN FUNCTION : SUPPORTS PROPERTY, PROTECTS AGAINST WAVE ACTION
MATERIAL : STONE IN CEMENT

SHORE: SANDY BEACH TO NORTH, BUT BULKHEAD STANDS ON EXPOSED
BEDROCK.

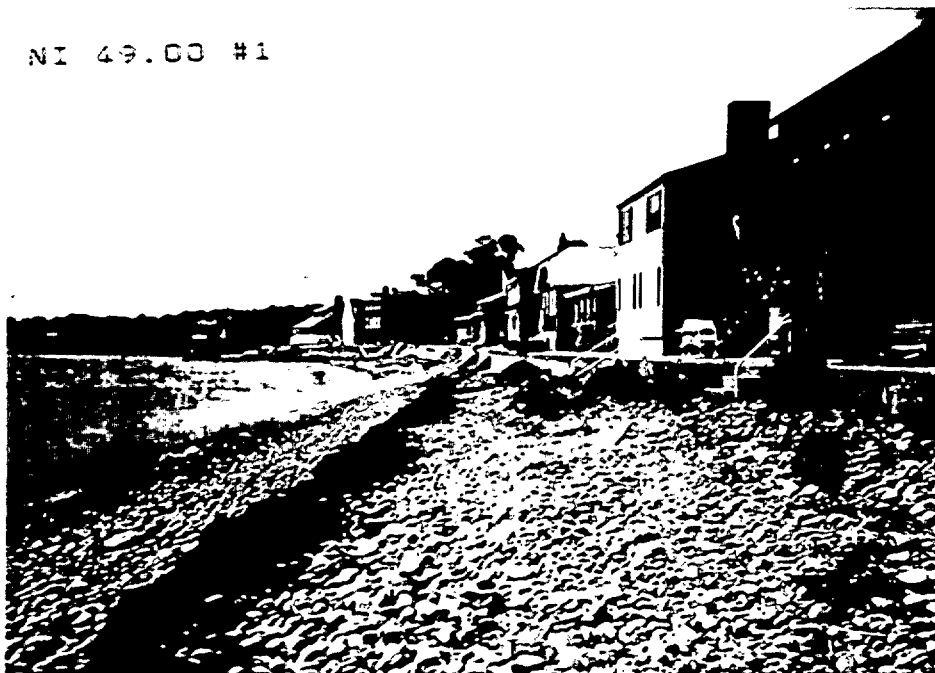
NI 49.00 #1

TYPE OF STRUCTURE: SEAWALL CONDITION: FAIR
MAIN FUNCTION : TO PROTECT LONG ROW OF PRIVATE HOMES FROM WAVE ACT
MATERIAL : CONCRETE

MOST HOMEOWNERS HAVE PLACED CEMENT DECKING BEHIND SEAWALL.
SHORE: SANDY BEACH

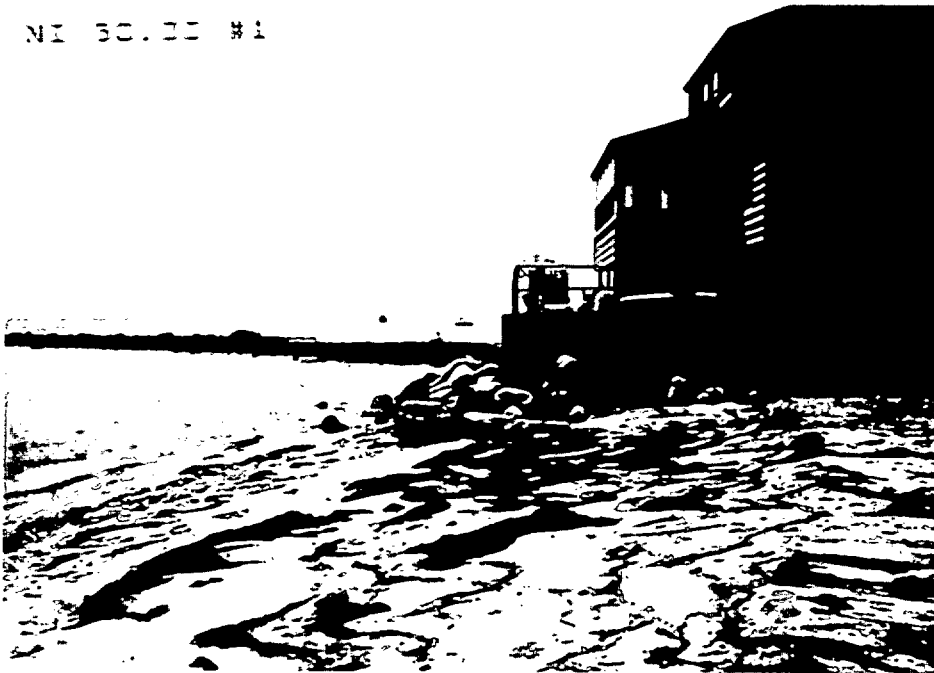
NI 30.11 #1

TYPE OF STRUCTURE: BULKHEAD CONDITION: GOOD
MAIN FUNCTION : FOUNDATION OF HOME
MATERIAL : CONCRETE

SHORE: SANDY BEACH TO NORTH, ROCKY POINT TO SOUTH

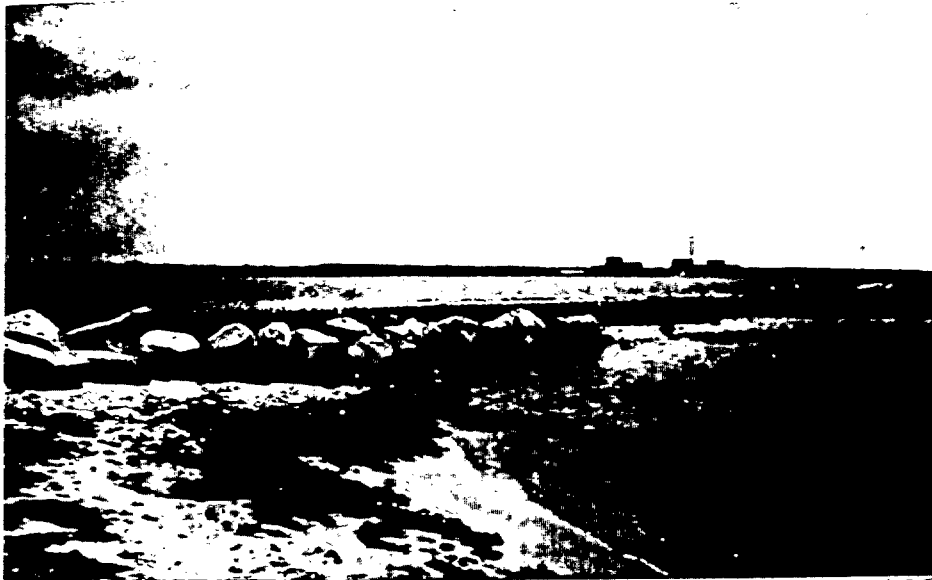
NI 51.00 #1

TYPE OF STRUCTURE: RIPRAP CONDITION: FAIR
MAIN FUNCTION : PREVENTS BREACHING OF POND POINT, PREVENTS EROSION
MATERIAL : STONE

SHORE: SANDY BEACH TO SOUTH, ROCKY POINT TO NORTH.

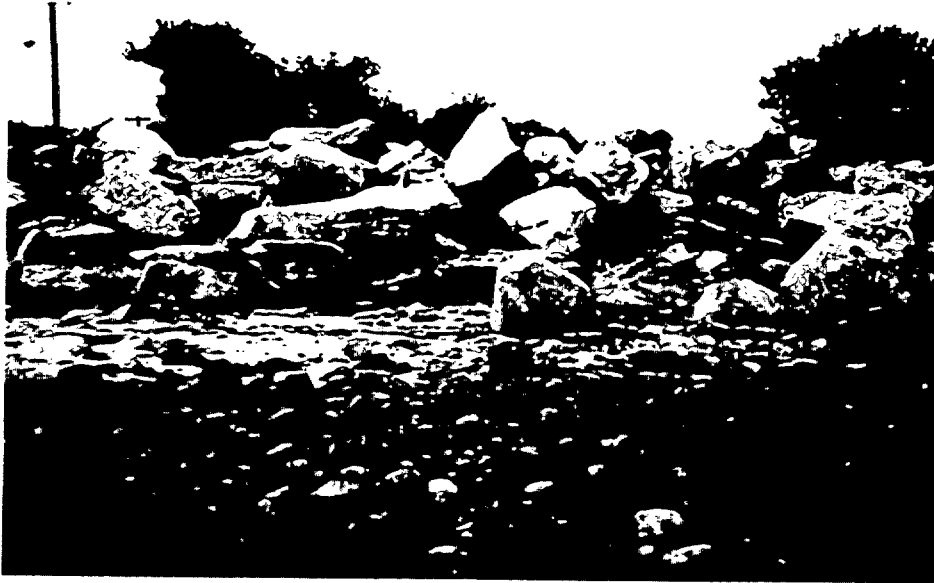
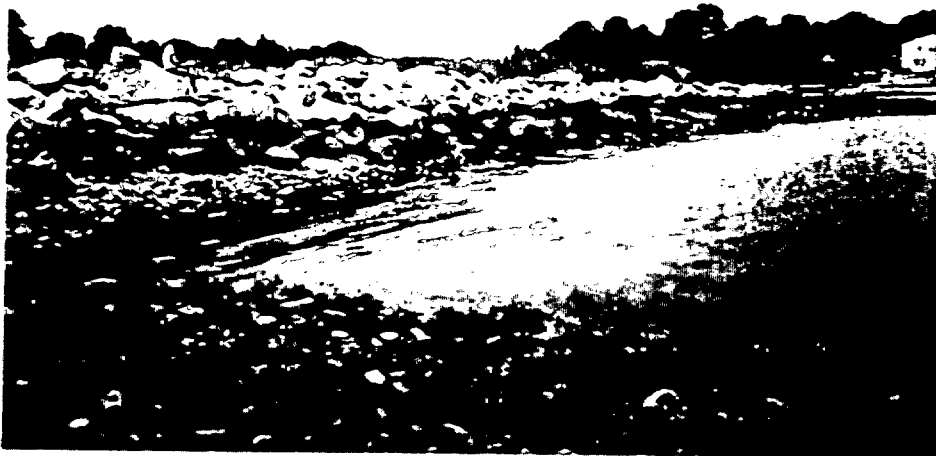
NI 52.00 #1

TYPE OF STRUCTURE: REVETMENT CONDITION: GOOD
MAIN FUNCTION : PREVENTS EROSION OF EMPTY LOT
MATERIAL : STONE

SHORE: ROCKY BEACH TO EITHER SIDE

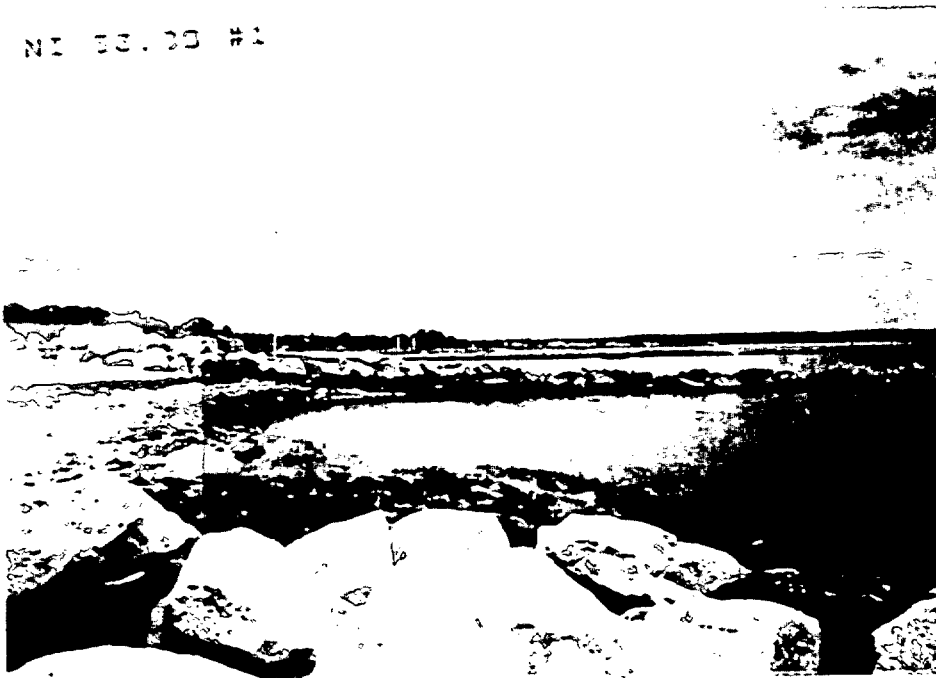
NI 03.00 #1

TYPE OF STRUCTURE: GROIN CONDITION: GOOD
MAIN FUNCTION : RETAINS SAND IN FRONT OF PRIVATE HOME
MATERIAL : STONE

SHORE: ROCK AND SAND BEACH TO SOUTH, ROCKY BEACH TO NORTH

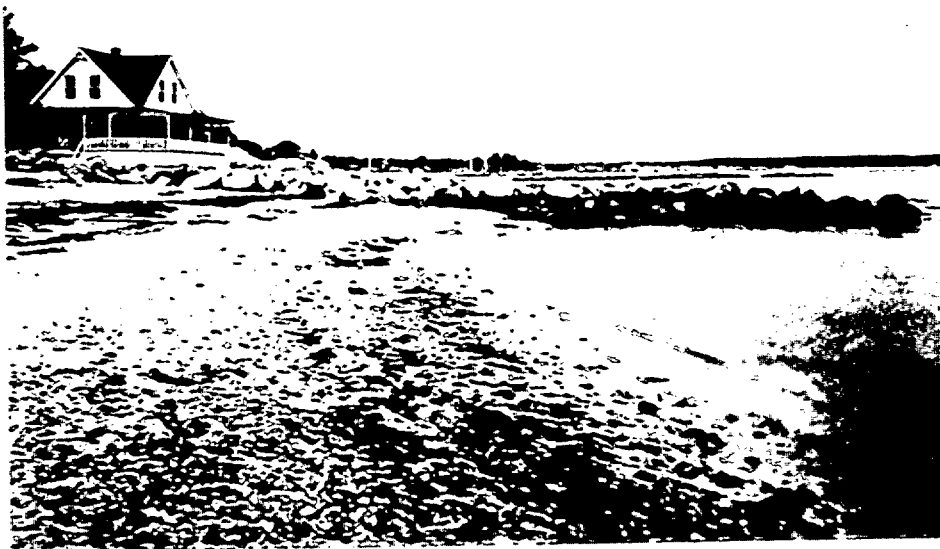
NI 84.02 81

TYPE OF STRUCTURE: GROIN CONDITION: GOOD
MAIN FUNCTION : RETAINS SAND TO SOUTH (ATTAWAN BEACH)
MATERIAL : STONE

SHORE: SANDY BEACH TO EITHER SIDE

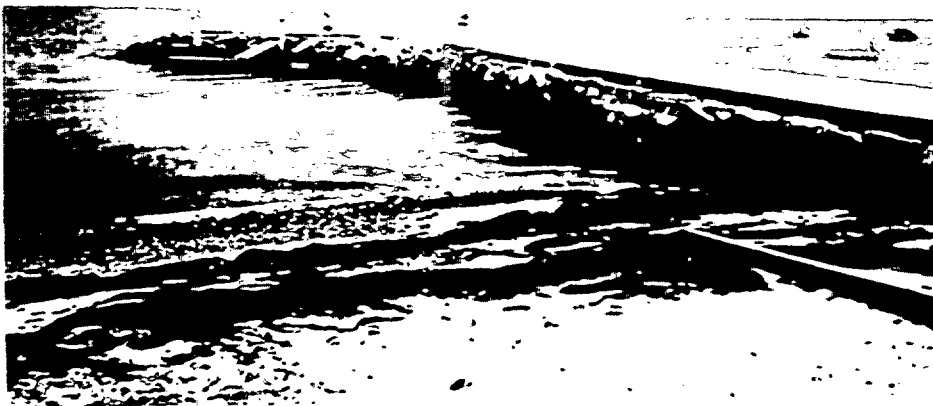
N1 35.00 #1

TYPE OF STRUCTURE: GROIN/JETTY CONDITION: GOOD
MAIN FUNCTION : PROTECTS NORTH END OF BEACH & FLOATING DOCK. STABI
MATERIAL : STONE

SHORE: SANDY BEACH TO EITHER SIDE (ATTAWAN BEACH)

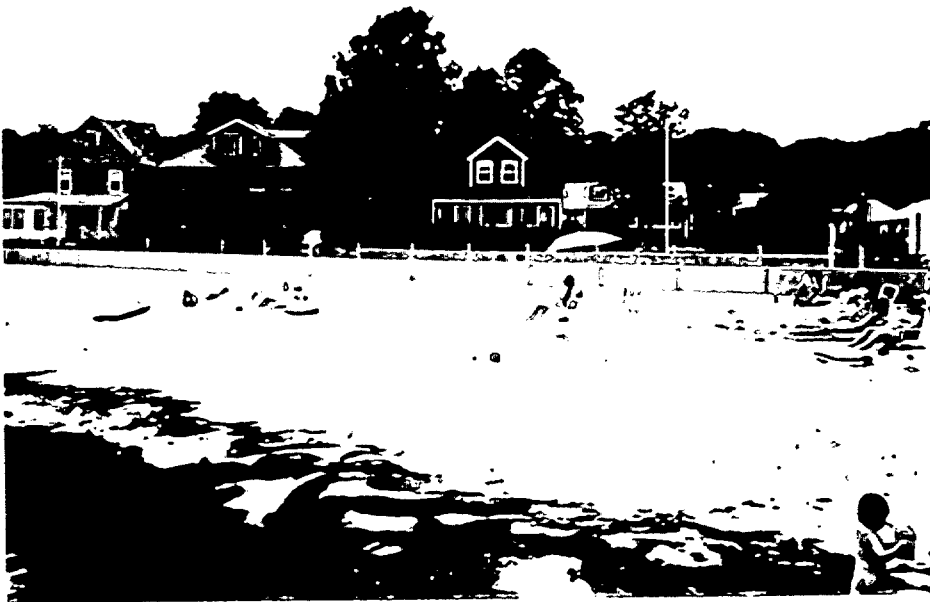
NI 55.00 #1

TYPE OF STRUCTURE: SEAWALL CONDITION: GOOD
MAIN FUNCTION : UNCLEAR. STABILIZE LAND, MARK PROPERTY, KEEP SAND
MATERIAL : CONCRETE

SHORE: SANDY BEACH

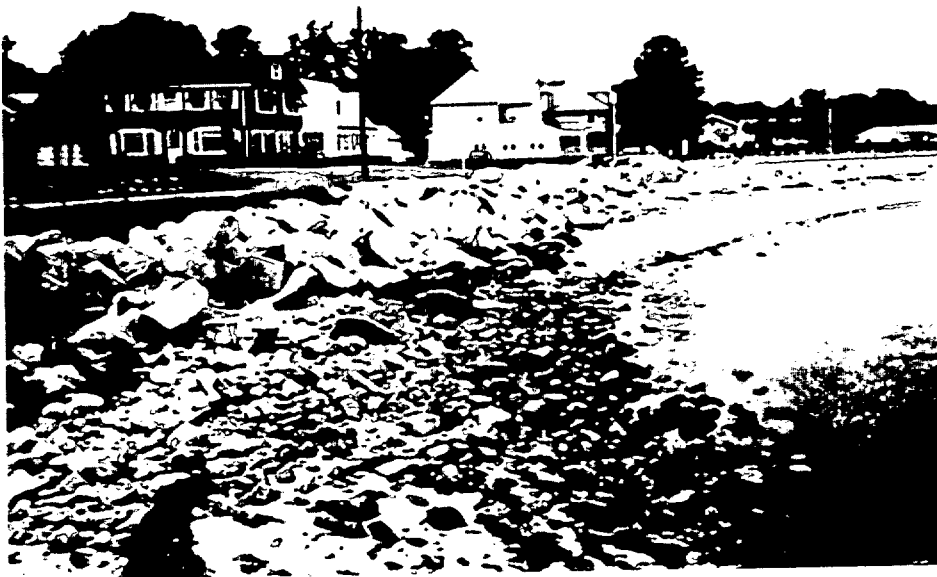
NI 67.00 #1

TYPE OF STRUCTURE: REVETMENT CONDITION: GOOD
MAIN FUNCTION : PROTECTS SLOPE BELOW ATTAWAN AVE FROM EROSION
MATERIAL : STONE

SHORE: SANDY BEACH

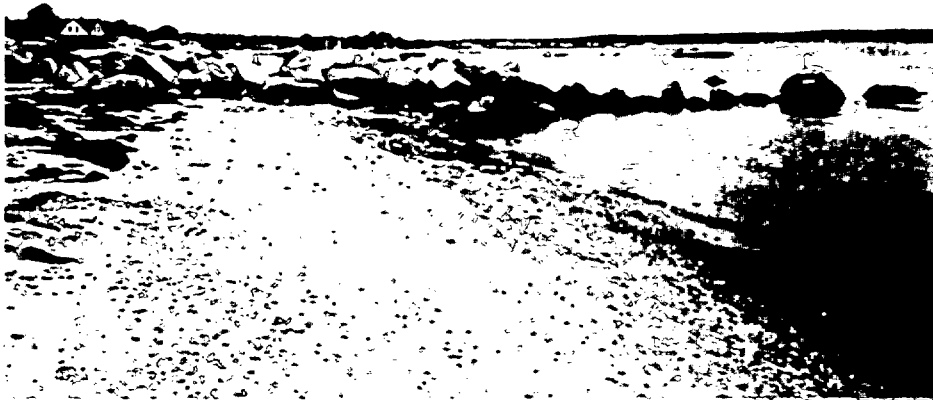
NI 53.00 #1

TYPE OF STRUCTURE: GROIN CONDITION: POOR
MAIN FUNCTION : RETAINS SAND TO SOUTH
MATERIAL : STONE

SHORE: SANDY BEACH

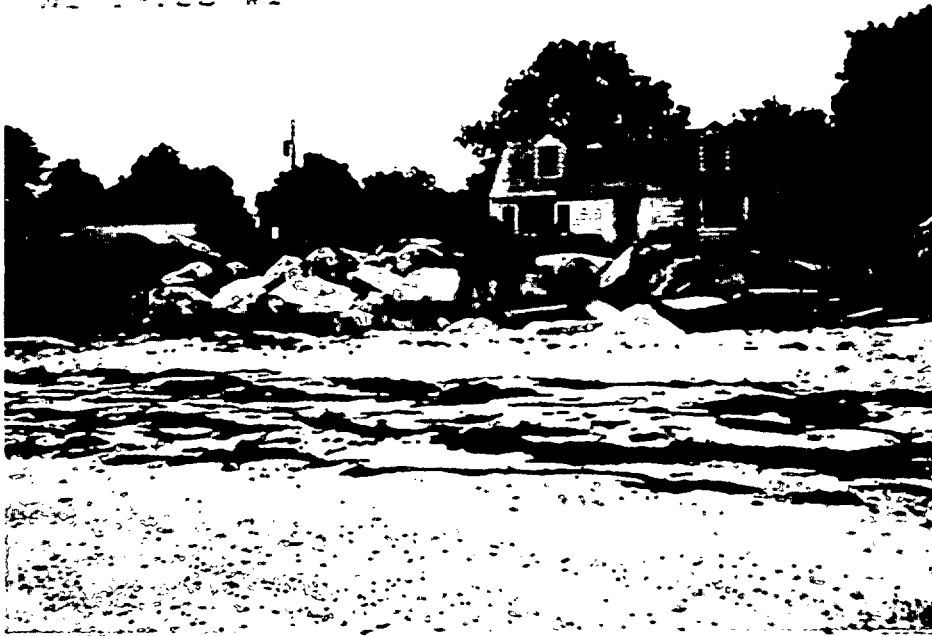
01 00.00 01

TYPE OF STRUCTURE: REVETMENT CONDITION: GOOD
MAIN FUNCTION : PROTECTS SLOPE BELOW ATTAWAN AVE FROM EROSION
MATERIAL : STONE

SHORE: SANDY BEACH TO NORTH, PROTECTIVE STRUCTURE TO SOUTH

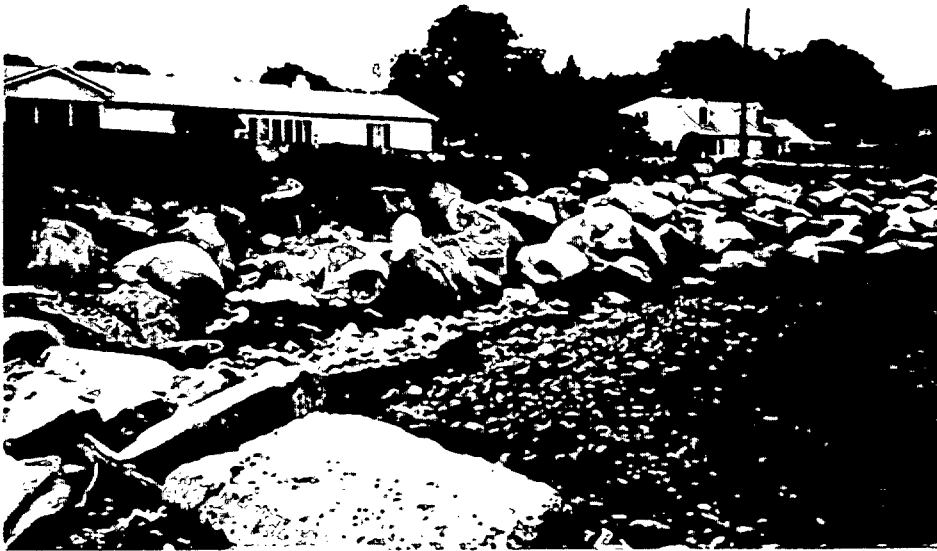
01 00.00 #1

TYPE OF STRUCTURE: SEAWALL/RIPRAP CONDITION: GOOD
MAIN FUNCTION : SUPPORT PRIVATE LOT/PREVENT EROSION OF SLOPE IN FR
MATERIAL : STONE IN CEMENT

SHORE: ROCKY BEACH

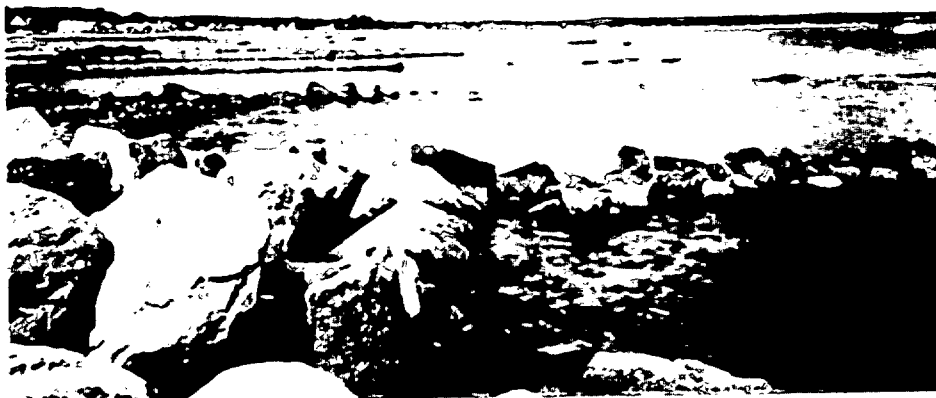
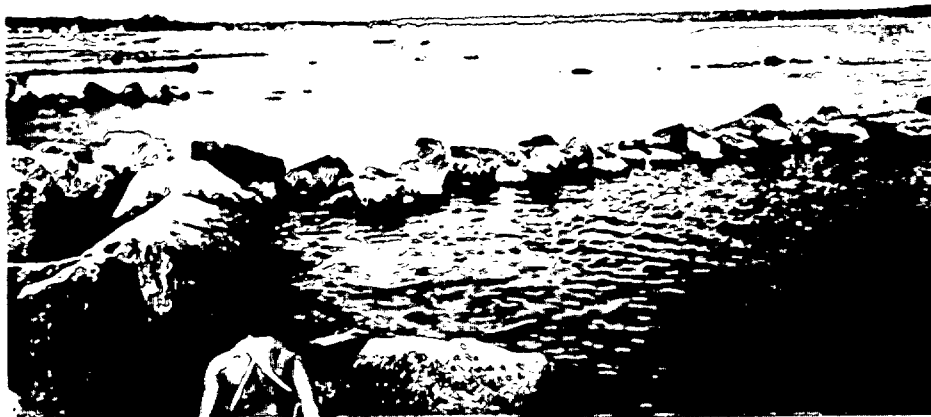
NI 61.00 #1

TYPE OF STRUCTURE: 5 GROINS CONDITION: POOR
MAIN FUNCTION : UNCLEAR. ATTEMPT TO TRAP SAND? NO SAND ACCUMULATE
MATERIAL : STONE

ROCKY SHORELINE

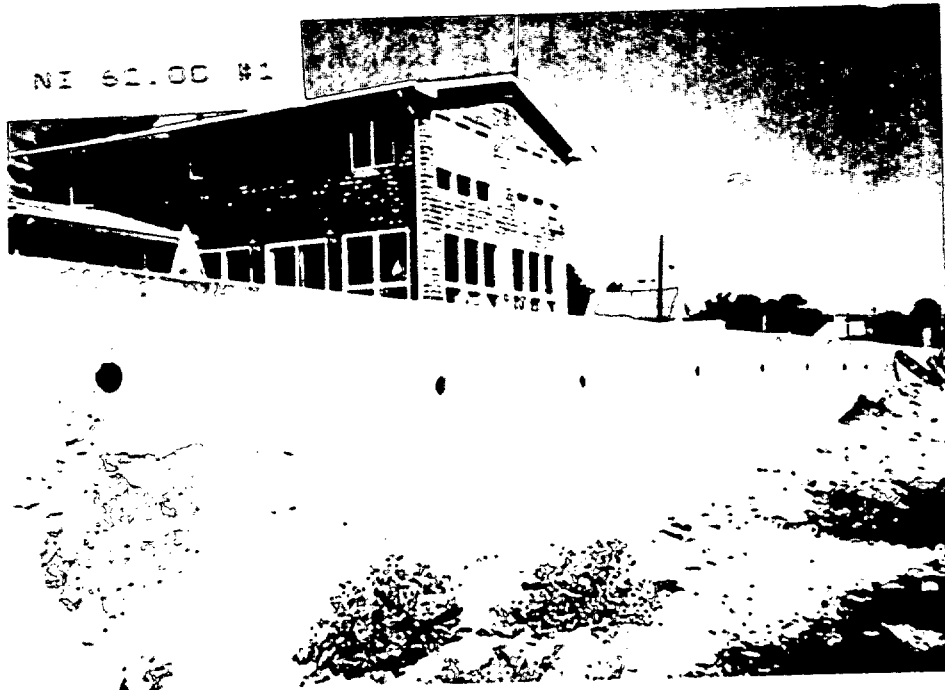
NI 62.00 #1

TYPE OF STRUCTURE: SEAWALL CONDITION: GOOD
MAIN FUNCTION : RETAINS LAND. NO EROSION PROTECTION AS SEAWALL IS
MATERIAL : CONCRETE

SANDY/ROCKY BEACH

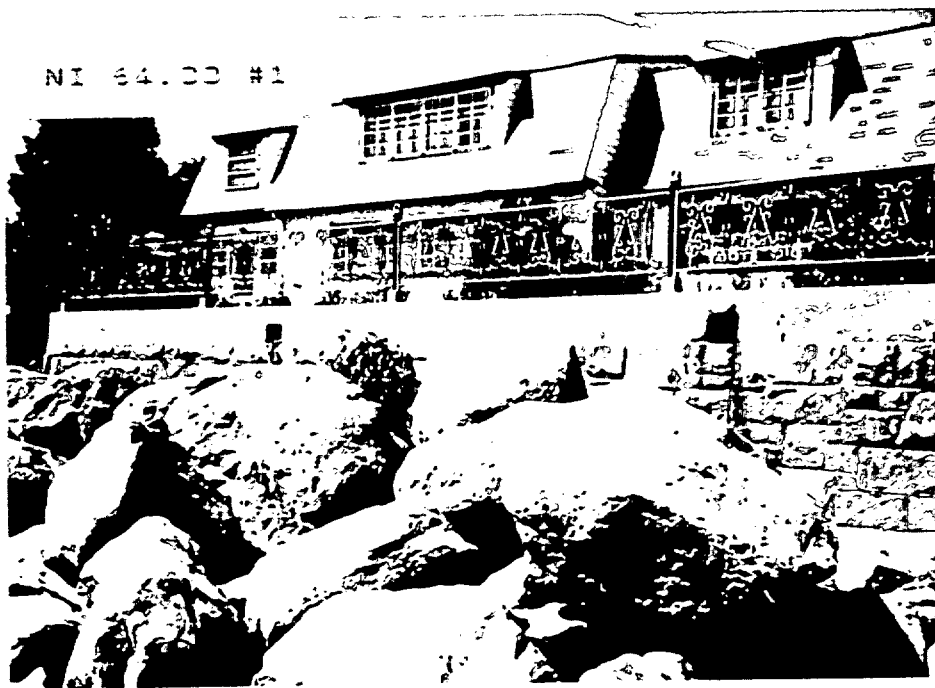
TYPE OF STRUCTURE: SEAWALL/RIPRAP CONDITION: GOOD
MAIN FUNCTION : RETAINS PROPERTY AND PREVENTS EROSION
MATERIAL : BLOCK IN CEMENT

SHORE: SANDY AND ROCKY

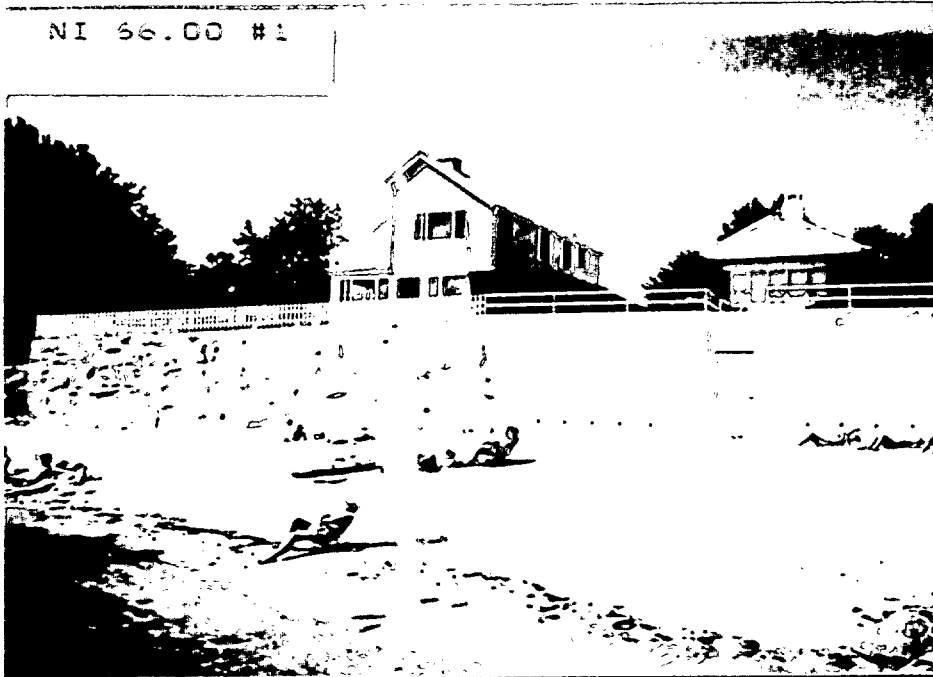
NI 66.00 #1

TYPE OF STRUCTURE: SEAWALL CONDITION: GOOD
MAIN FUNCTION : RETAINS PROPERTY/PROTECTION FROM WAVE ACTION
MATERIAL : STONE/CONCRETE

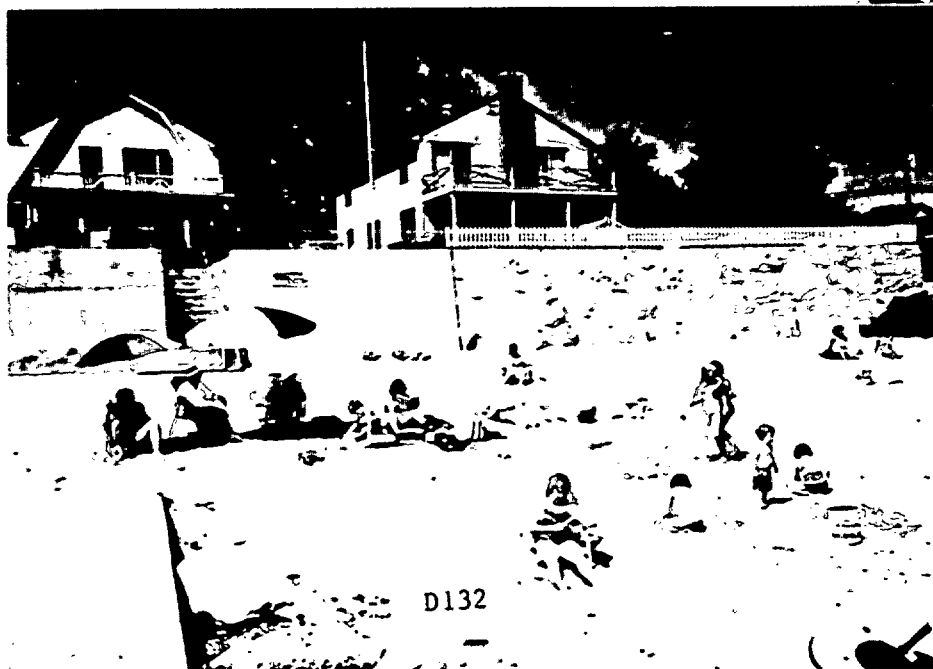
SANDY BEACH

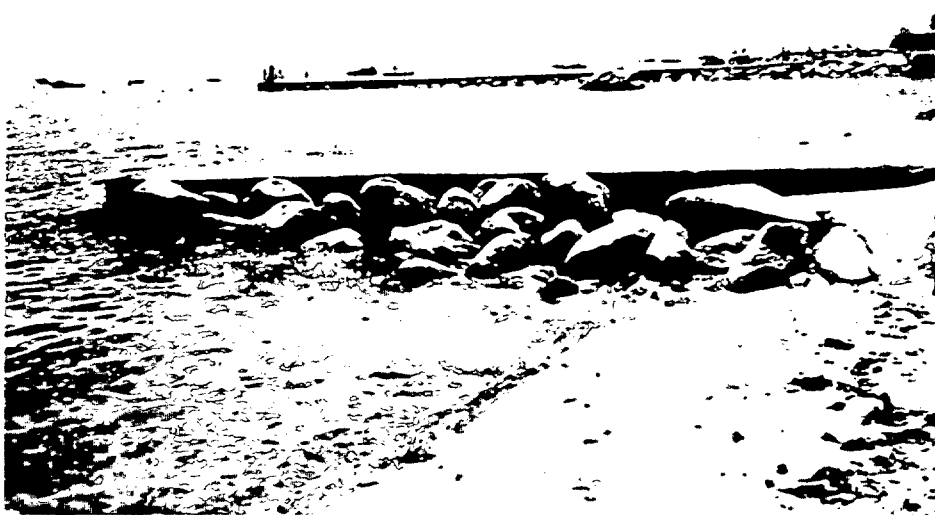
NI 62.00 #1

TYPE OF STRUCTURE: GROIN CONDITION: GOOD
MAIN FUNCTION : RETAINS SAND TO NORTH
MATERIAL : CONCRETE

SANDY BEACH TO NORTH, SAND AND ROCK BEACH TO SOUTH

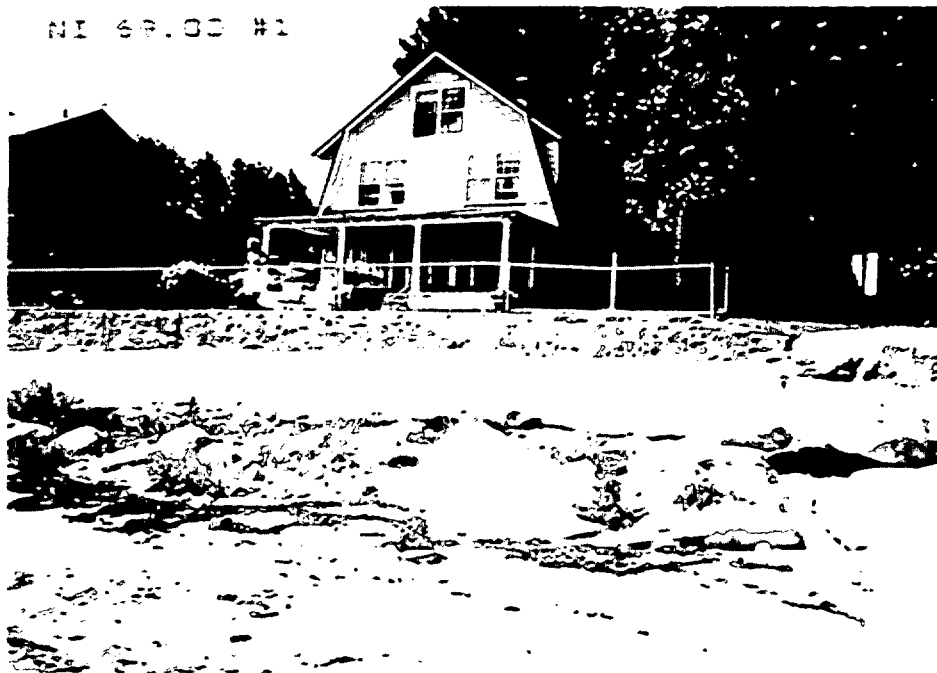
TYPE OF STRUCTURE: SEAWALL CONDITION: GOOD
MAIN FUNCTION : RETAINS LAND AND PREVENTS EROSION
MATERIAL : STONE IN CEMENT

SAND AND ROCK BEACH

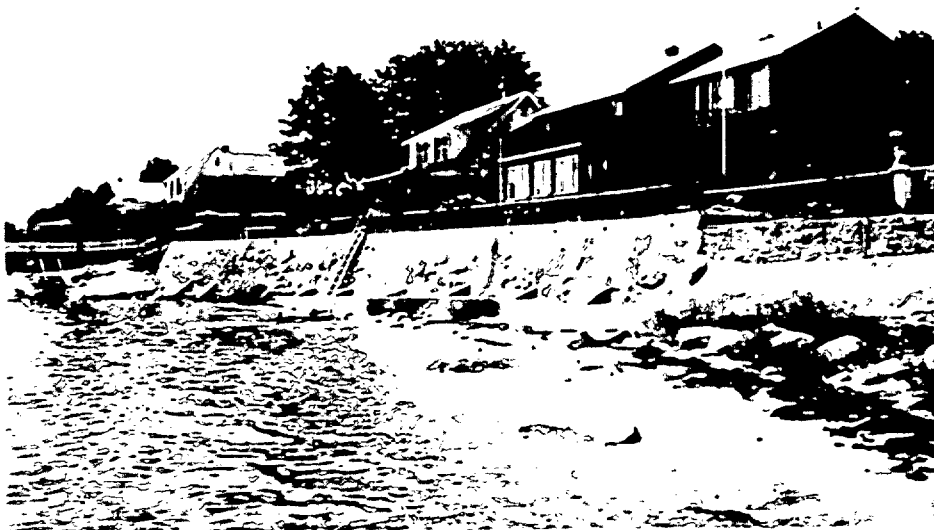
NI 70.00 21

TYPE OF STRUCTURE: SEAWALL CONDITION: GOOD
MAIN FUNCTION : RETAINS PROPERTY AND PREVENTS EROSION
MATERIAL : STONE IN CEMENT

ROCK AND SAND BEACH

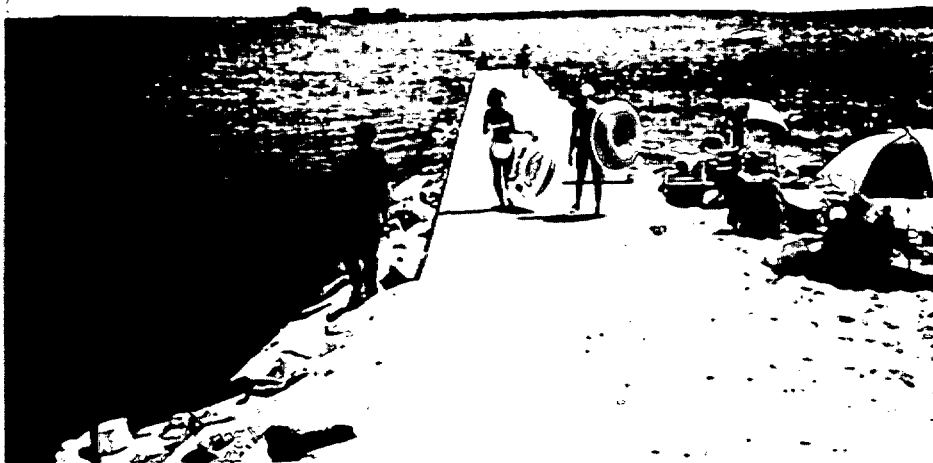
NI 71.00 #1

TYPE OF STRUCTURE: GROIN CONDITION: GOOD
MAIN FUNCTION : RETAINS BEACH TO SOUTH
MATERIAL : STONE/CEMENT

SAND AND ROCK BEACH TO NORTH, SANDY BEACH TO SOUTH

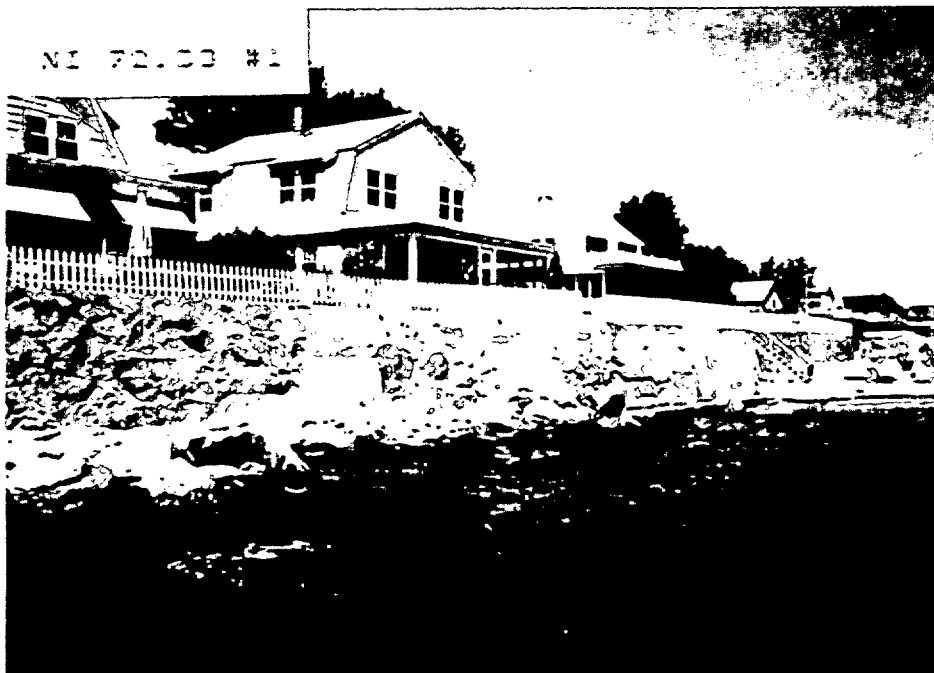
TYPE OF STRUCTURE: SEAWALL CONDITION: GOOD
MAIN FUNCTION : RETAINS PROPERTY AND PREVENTS EROSION
MATERIAL : STONE/CEMENT

ROCKY IN FRONT. LINED WITH STRUCTURES SOUTH, SANDY BEACH TO
NORTH.

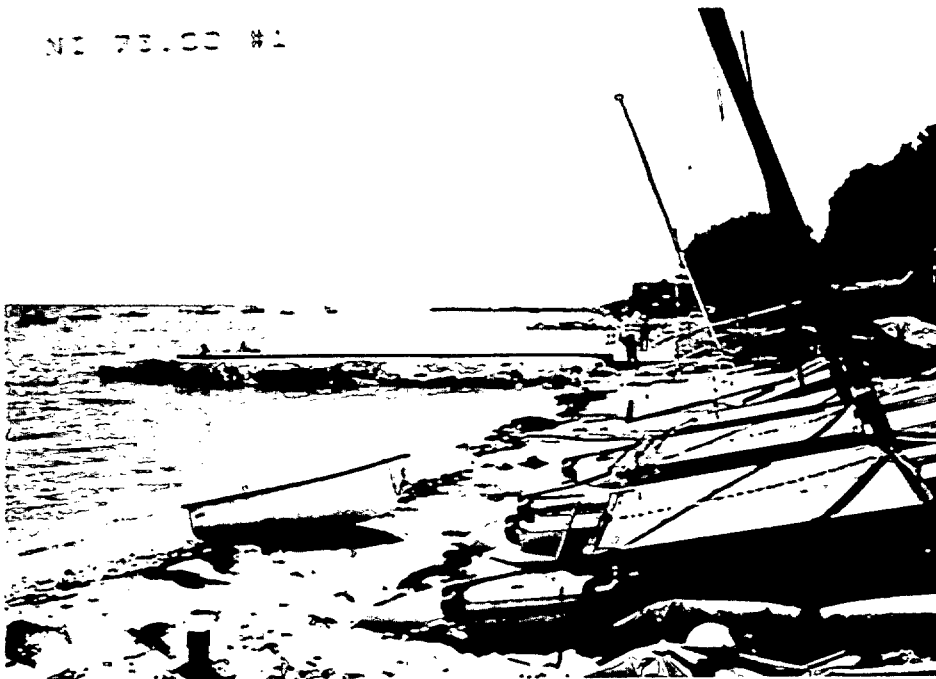
NI 73.00 #1

TYPE OF STRUCTURE: GROIN CONDITION: GOOD
MAIN FUNCTION : RETAINS BEACH TO NORTH
MATERIAL : CONCRETE

SANDY BEACH TO NORTH, LINED WITH STRUCTURES TO SOUTH.

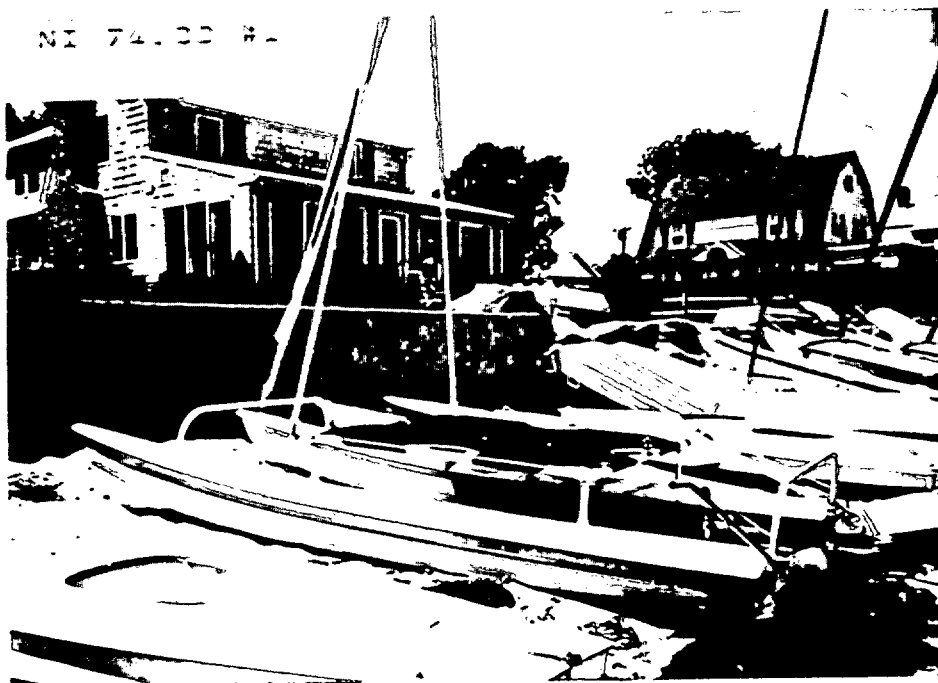
TYPE OF STRUCTURE: SEAWALL CONDITION: FAIR
MAIN FUNCTION : RETAINS PRIVATE LOT TO PROTECT AGAINST WAVE ACTION
MATERIAL : STONE IN CEMENT

SANDY BEACH TO NORTH AND IN FRONT, LINED WITH PROTECTIVE
STRUCTURES TO SOUTH.

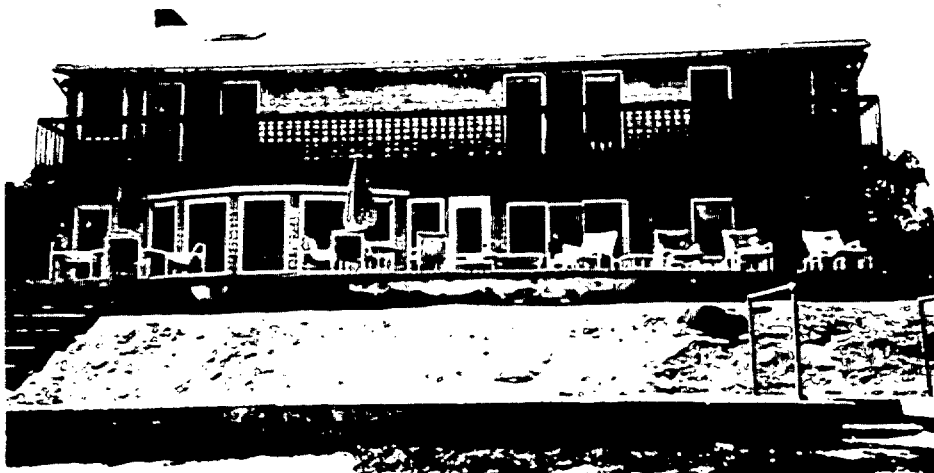
NI 73.00 #1

TYPE OF STRUCTURE: SEAWALL CONDITION: GOOD
MAIN FUNCTION : RETAINS PRIVATE LOT. PREVENTS WAVE EROSION.
MATERIAL : CEMENT

SHORE: LINED WITH STRUCTURES

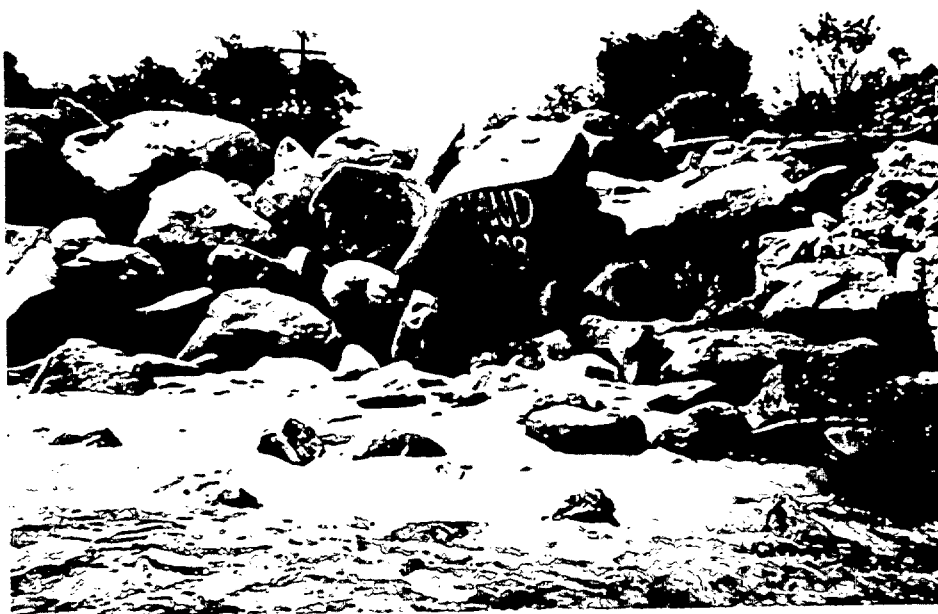
TYPE OF STRUCTURE: REVETMENT CONDITION: GOOD
MAIN FUNCTION : RETAINS PROPERTY AND PREVENTS EROSION
MATERIAL : LARGE STONES

SHORE: LINED WITH STRUCTURES

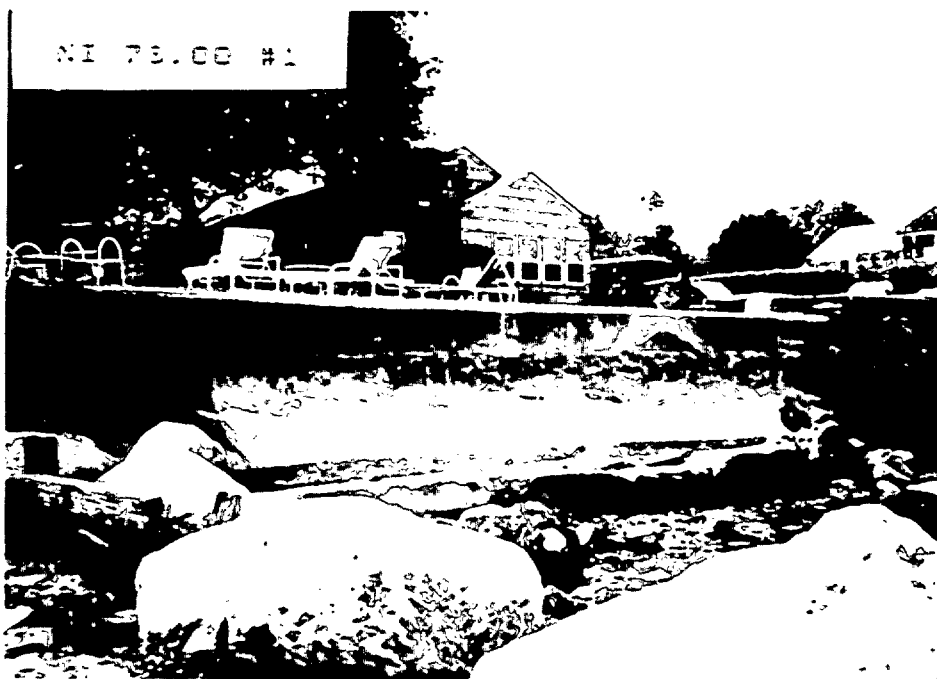
TYPE OF STRUCTURE: SEAWALL CONDITION: GOOD
MAIN FUNCTION : RETAINS LOT AND PREVENTS EROSION
MATERIAL : STONE IN CEMENT

SHORE: LINED WITH STRUCTURES

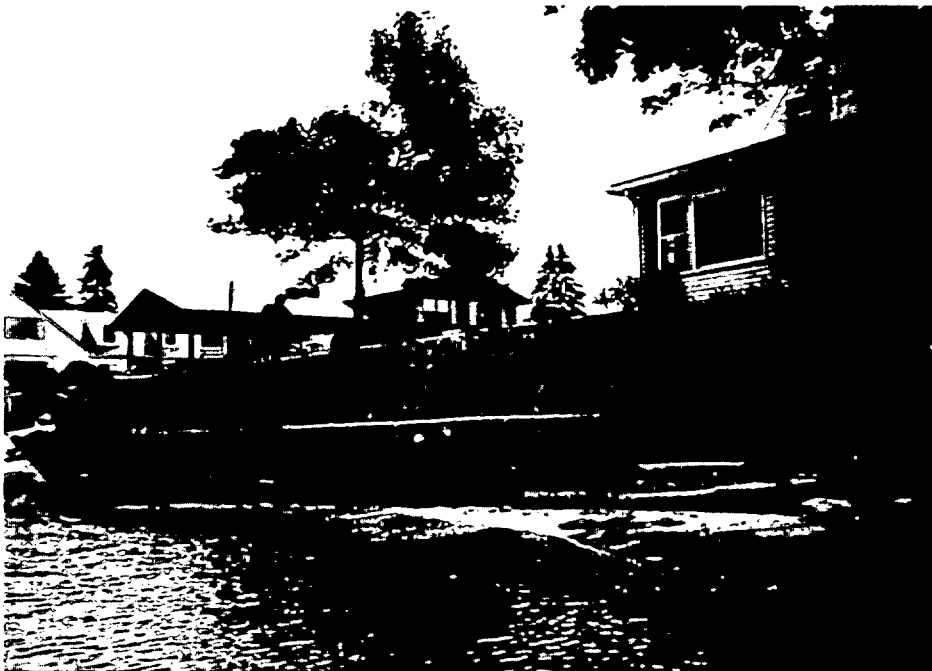
TYPE OF STRUCTURE: SEAWALL CONDITION: GOOD
MAIN FUNCTION : RETAINS LOT AND PREVENTS EROSION
MATERIAL : STONE IN CEMENT

BOAT RAMP EXTENDS ADJACENT TO SOUTH END OF SEAWALL AT END OF
SEA SPRAY AVE. SHORE LINED WITH STRUCTURES.

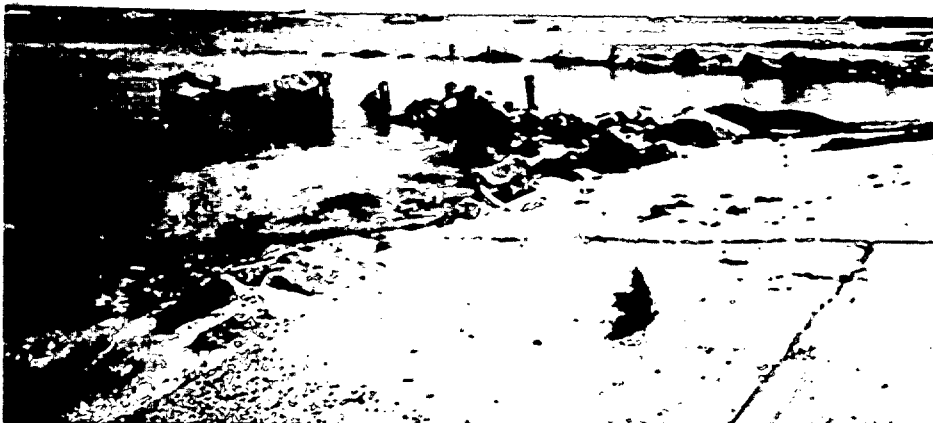
NI 81.00 41

TYPE OF STRUCTURE: 3 GROINS CONDITION: POOR
MAIN FUNCTION : RETAIN SAND
MATERIAL : STONE

SHORE LINED WITH STRUCTURES

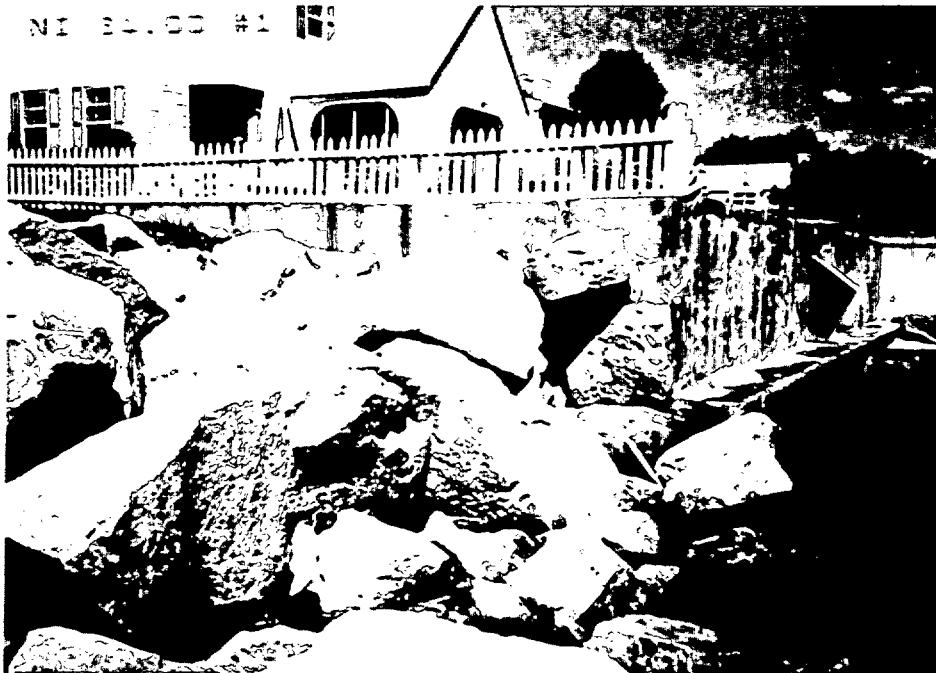
TYPE OF STRUCTURE: REVETMENT CONDITION: GOOD
MAIN FUNCTION : RETAINS EMPTY LOT/ PREVENTS EROSION FROM WATER
MATERIAL : STONE

SHORE: LINED WITH STRUCTURES

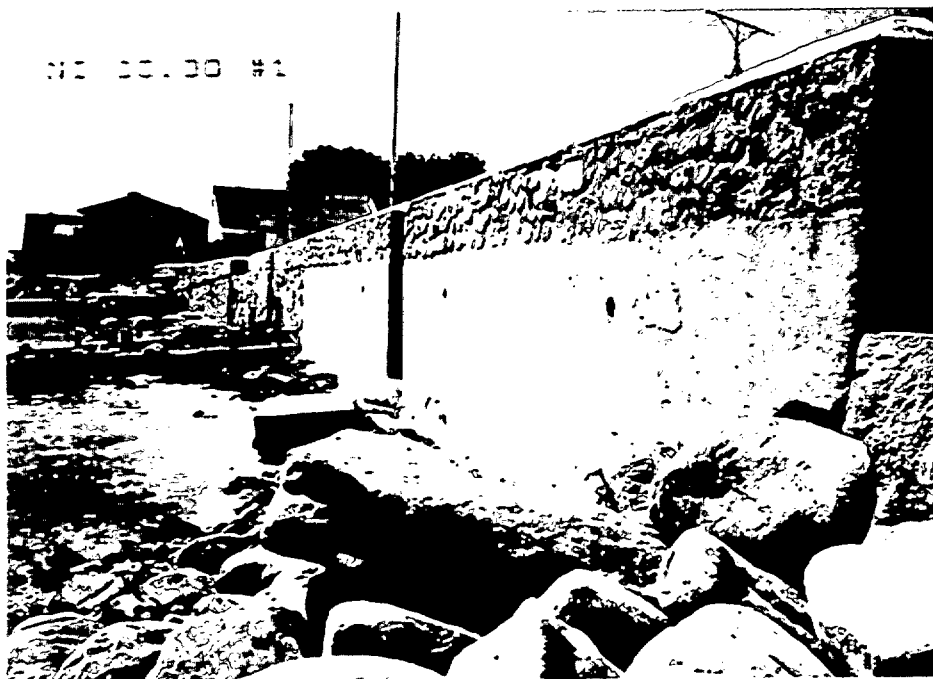
TYPE OF STRUCTURE: SEAWALL CONDITION: GOOD
MAIN FUNCTION : RETAINS LAND AND PREVENTS EROSION
MATERIAL : CEMENT/STONE

SHORE: LINES WITH STRUCTURES
